Repair specialists describe how to strengthen a shear wall, protect post-tensioning tendons, and color-match a patch

Concrete Repair Case Studies

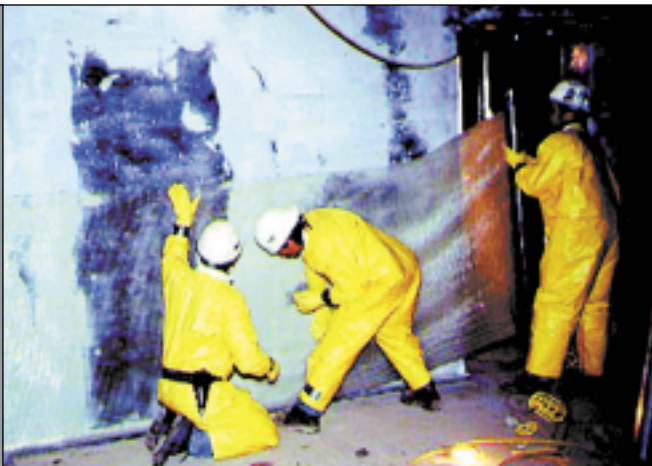
General contractor Roglin's, Aberdeen, Wash., exposed the shear walls by mechanically removing all plaster. The walls had significant areas of rock pockets and poorly consolidated concrete. These areas required repair before the composite material could be installed.

Glass-fiber composite fabric was used to repair shear walls in the earthquake-damaged Gray's Harbor County Courthouse.

After the four wall surfaces were mechanically prepared and vacuumed, workers applied a saturated epoxy that was modified with inert fillers. This epoxy acted as a primer and smoothing compound. At the same time, we were saturating the glass-fiber composite with a neat epoxy saturating resin using an impregnator/saturating machine. Once the material was saturated, it was cut to appropriate lengths and transported to wall locations. A crew of three workers installed the compos-

ite the full height and width of each wall. Before the final set of the composite, they set fiber anchors along the perimeter of the fiber to anchor the edges and to transfer stresses back into the concrete elements.

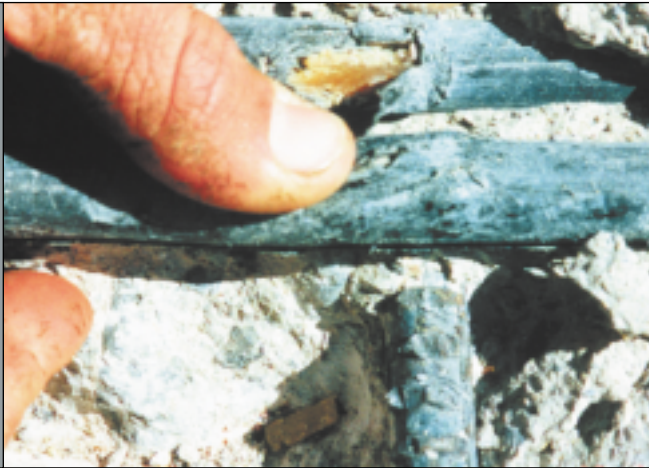
On one recent project, we found the unbonded tendons in the top deck of a two-story parking garage had been exposed to corrosion because de-icing salt and water had penetrated the protective sheathing through tears, punctures, and the unprotected ends of the tendons. The protective greases had deteriorated over time and allowed this water to fill the voids between the exterior wrap and the steel strands.

This parking structure was repaired by encapsulating the unbonded tendons with polyurethane that was injected into the tendon sheathing.

To protect the strands from corrosion, we injected specially formulated polyurethane into the strand sheaths

Injection ports similar to those used for epoxy injection were mounted on the tendons to allow the transfer of the polyurethane into the sheathing to fill the void system around the tendon. Once the ports were installed, we forced compressed air into one end to determine if air could flow through the sheathed tendon system and if any free water was present. We then injected urethane at one high point and one low point. Injection ports were installed at the tendon ends to monitor the polyurethane flow. Once completely filled with polyurethane, we cut the sheathing at several points to verify curing and strand encapsulation. Finally, we sandblasted the ends to remove corrosion products and painted them with a zinc-rich paint.

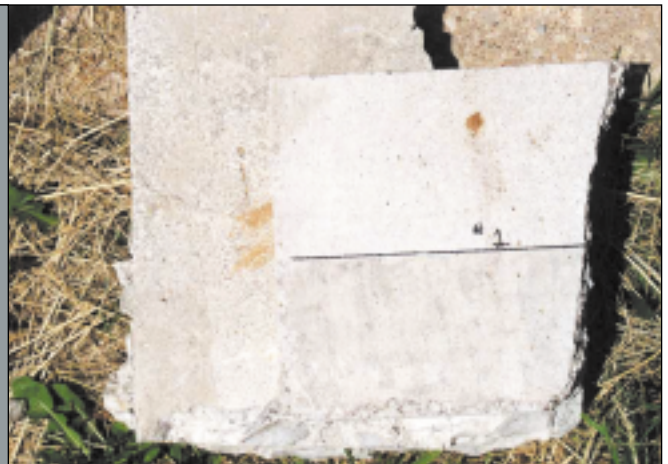
We were asked to correct a poor match on patches that had been recently installed on a 1920s concrete structure. The localized cementitious patches were noticeably lighter in color than the adjacent concrete. But since the patches were structurally sound, well-bonded, and matched the texture and finish of the original concrete, the owner did not want to remove and replace them.

A non-film-forming pigmented stain provided a good color match to the original concrete and lower maintenance for the owner of this historic structure. Upper right is the original repair, lower right is the modified repair, and the left side is the original concrete.

The solution was non-film-forming pigmented stains, which we found effective in altering the color of the repair concrete to match the original material. A proprietary water-based resin-and-pigment coating, used on other projects as a stain for blending new concrete block with adjacent existing construction, had several advantages for this repair. The stain was effective in changing the patch color, was vapor-permeable, and did not add a visible surface film. A relatively transparent film-forming coating was also evaluated but was not as effective as the stain in achieving a color match. ■
