Problem **Radial cracks around columns**

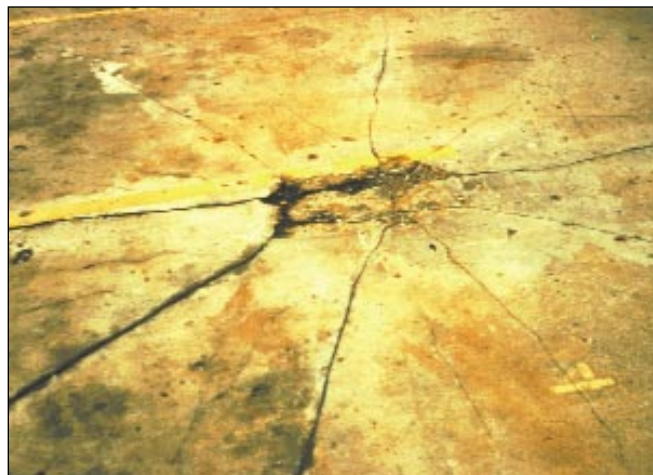
Certain patterns and wider cracks may indicate a structural overload. The typical pattern of these cracks is radial cracks originating at the column and circumferential cracks around the column at a distance approximately equal to the depth of the slab. If these cracks appear to be more pronounced and wider, it is probable that the as-built capacity of the slab is below the actual loads (including self-weight) applied to the slab.

This overload may be caused by loads for which the slab was not originally designed, by inadequate design, or by construction deficiency. Construction deficiencies could include inadequate concrete strength or early removal of forms before the concrete achieved the required strength. The

as-built depth of the slab could be less than designed or the top mat of slab reinforcement may have been improperly placed. A variation of 1 or 2 inches in the elevation of the bars could reduce shear or flexural capacity of the column-slab junction by 20 to 30%.

Cracks radiating from a supporting column are a structural failure indicating that the slab is overloaded.

If analysis determines that there is a deficiency that needs to be corrected, there are several approaches. One is to increase the thickness of the slab with a concrete overlay and supplemental slab reinforcing. Unfortunately this also will result in additional weight and may not be effective. Additional slab thickness can be provided on the slab soffit by installing a drop panel. Additional reinforcing bars can be installed in

grooves cut in the top surface of the slab around the column, but these bars usually will not go through the column, which limits the effectiveness, and the patched grooves may affect durability.

An often-used retrofit technique is to install concrete shear collars or steel brackets on the underside of the column-slab junction. This repair increases the capacity of the connection by increasing the perimeter of the load transfer from the slab into the column. It also reduces the clear span of the slab between the columns, which results in reduced bending moments and reduced stresses in the existing top-of-slab reinforcing. For this to be effective, the connection of the concrete shear collar or steel brackets to the column must provide for a transfer of vertical slab loads into the column.
