An analysis of pavement defects

Here is some long-needed help in recognizing the more common types of pavement cracks, along with some indications of probable causes.

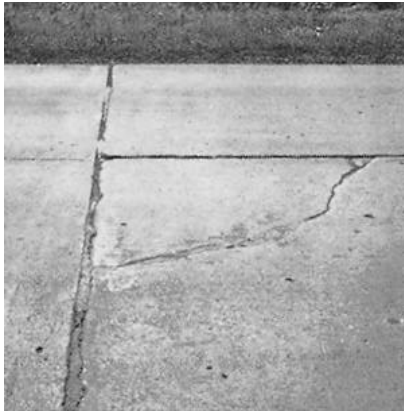
Figure 1 shows a fairly typical corner break in which the crack runs from the transverse joint of the pavement to the center joint. Where this occurrence is associated with wheel loads the legs on both sides will generally be from 2 to 4 feet long. When the legs on one or both sides are less than 2 feet long, it is likely that the defect is the result of temperature stresses or unequal expansion restraint, such as might result from infiltration or the presence of a plug of concrete in the joint space.

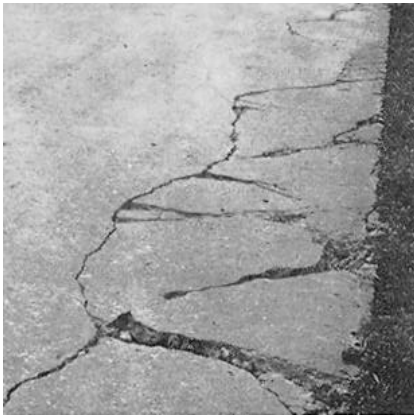
Figure 3

This type of defect is generally confined to an area within 2 feet of the edge of the slab. It may consist of either a long longitudinal crack or

a series of cracks in the form of arcs leaving and returning to the edge of the pavement, as shown in Figure 3.

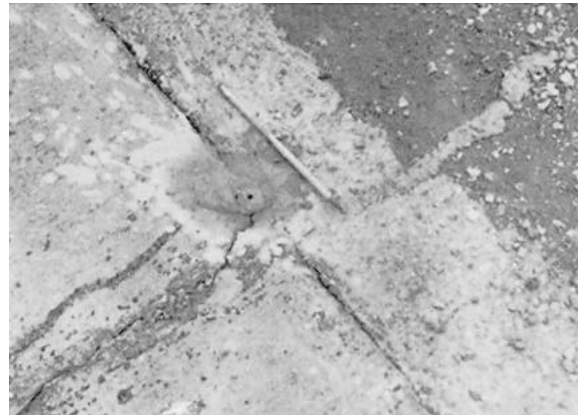
Figure 4

While wheel loads, load repetitions and the accompanying deflections are the immediate causes of pumping (Figure 4), this phenomenon is more immediately related to such factors as surface drainage, the effectiveness with which loads are transferred, and the character of subbase and subgrade soil. Pumping can occur at joints, cracks and edges, and the name is quite descriptive of what actually takes place. The slab, as it deflects under load and then recovers, actually functions as a crude but effective pump to bring a mixture of subsoil and water to the surface.

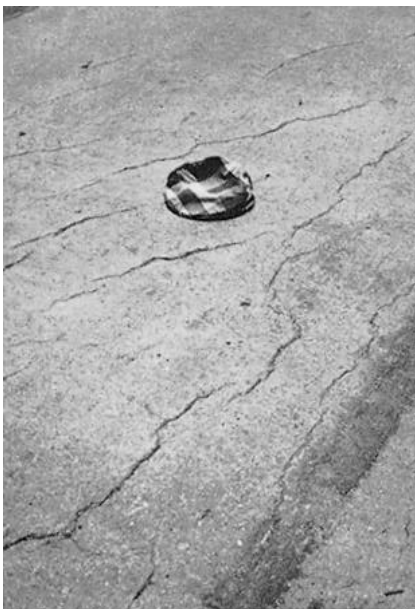
Figure 5

Short diagonal cracks in the interior of slabs, such as those shown in Figure 5, are generally plastic shrinkage cracks. They tend to converge toward the center of the slab in the direction of paving. While the surface openings are quite conspic-

uous, cracks of this type seldom extend very far beneath the surface. Plastic shrinkage cracks form during the early hardening of concrete when wind velocity, low humidity, high air temperature (or all three factors acting together) cause water to evaporate from the concrete surface more rapidly than it is replaced by bleeding.

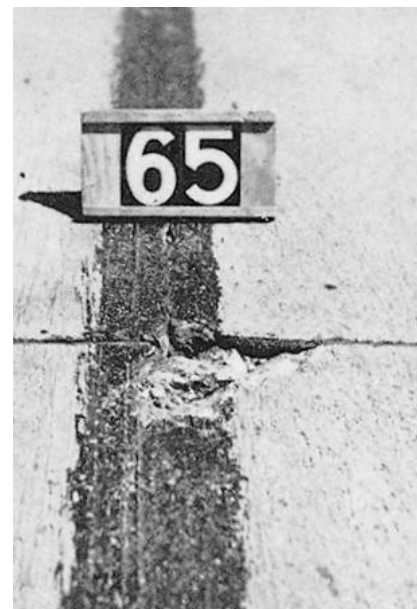
The unsightly defects shown in Figures 6 and 7 are what are known as spalls. They are generally quite shallow and almost never do they extend through the depth of the slab. Faulty construction practices are generally responsible for spalling, although poor maintenance, especially failure to keep foreign material from accumulating in

joints and cracks, may also be a factor. Edge spalls, especially at the intersections of transverse joints or cracks with longitudinal center joints, are sometimes incorrectly classified as corner breaks. The primary cause in this case is not load but interior restraint stresses.

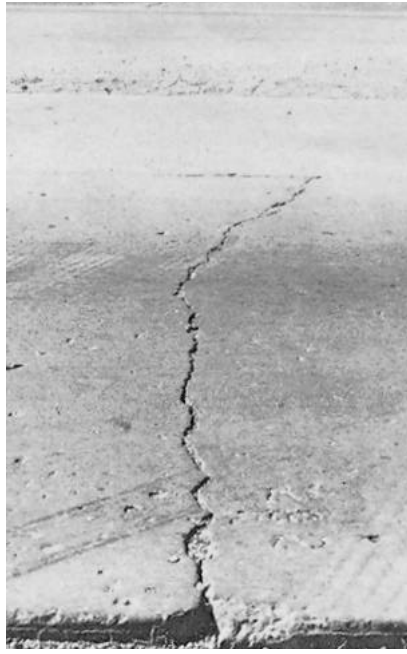
Transverse cracks which occur near the center of slabs 40 feet in length are usually simple contraction cracks Figure 8 shows a typical example. When transverse cracks occur within 2 or 3 feet of a joint (Figure 9), and there is no accompanying faulting of the joint, the cause is usually frozen dowels.

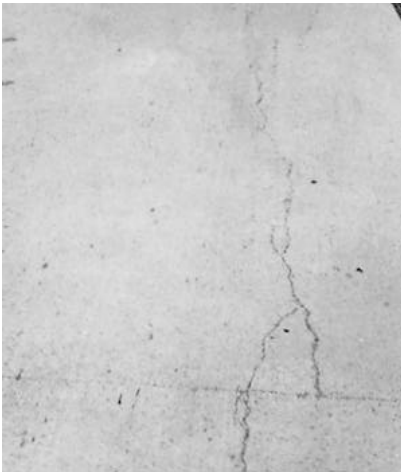
Figure 10

Full length longitudinal cracks located within 3 feet of the center joint (Figure 10) may be caused by an ineffective center joint. Similar cracks near the center of a 12-foot traffic lane (Figure 11) are more likely to be caused by serious loss of subgrade support near the edge of the pavement. In this case wheel loads are often a contributing factor.

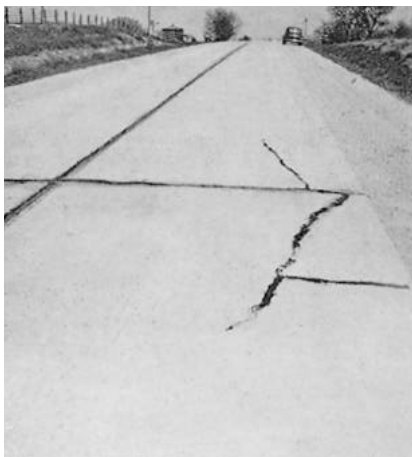
Figure 12

When there is expansion restraint, near the outside edge of a pavement short longitudinal cracks may tree out from transverse joints (Figure 12). The restraint and the resulting splitting action may be due to the presence of a plug of concrete in the joint space near the edge of

the slab. Frozen dowels may also be a factor in this type of cracking.

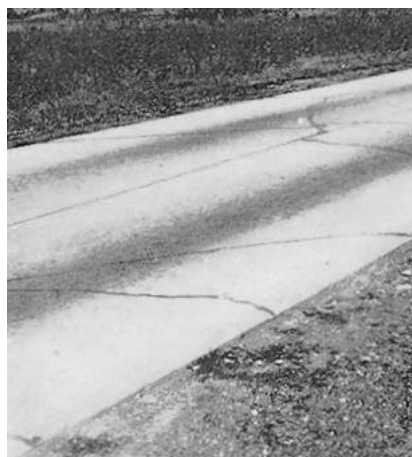
Figure 13

These multiple diagonal cracks are usually caused by heaving of the slab, due to expansive subgrade soils, frost action (Figure 13) or careless mudjacking (Figure 14). Applied loads are not in any way involved in this type of pavement defect.
